WISCONSIN TEST FACILITY
GROUND TERMINAL CORROSION STUDY

Michael Genge Edwin Wolkoff Paul Bergschneider

April 1978

U. S. Naval Electronic Systems Command Washington, D. C.

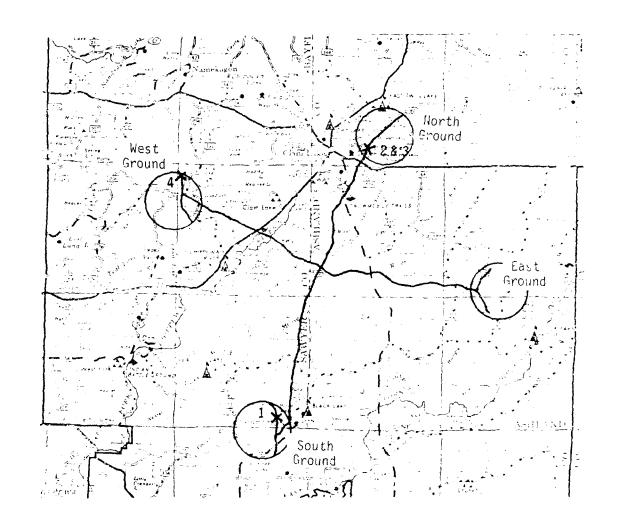
Figure 1 GROUND TERMINAL INSPECTION POINTS AT THE WISCONSIN TEST FACILITY

Each antenna segment at the WTF is connected to the center of a ground terminal as shown in Figure 1. These grounds were located in areas where measurements indicated low near-surface resistivity. This was done to achieve low resistance grounds and to minimize the resulting surface electric fields. Figure 1 also indicates that the north ground partially shares the light-of-way with the North-South antenna segment. The southern half of the north ground terminal was placed in the antenna right-of-way, but the northern half extends beyond the antenna.

During the late summer and early fall of 1977, the Wisconsin Test Facility ground terminals were examined at four different locations, as identified in Figure 1. At each location, after the position of the ground terminal was located using a magnetic field detector, a back-hoe was used to uncover a minimum of eight feet of the ground terminal. A visual inspection of the copper cable was then performed and the diameters of the individual strands of the cable were measured with a vernier caliper. Figures 2 and 3 illustrate typical inspection locations after the ground terminals had been located and exposed.
